MCC Power Capacitor Disconnect Switch

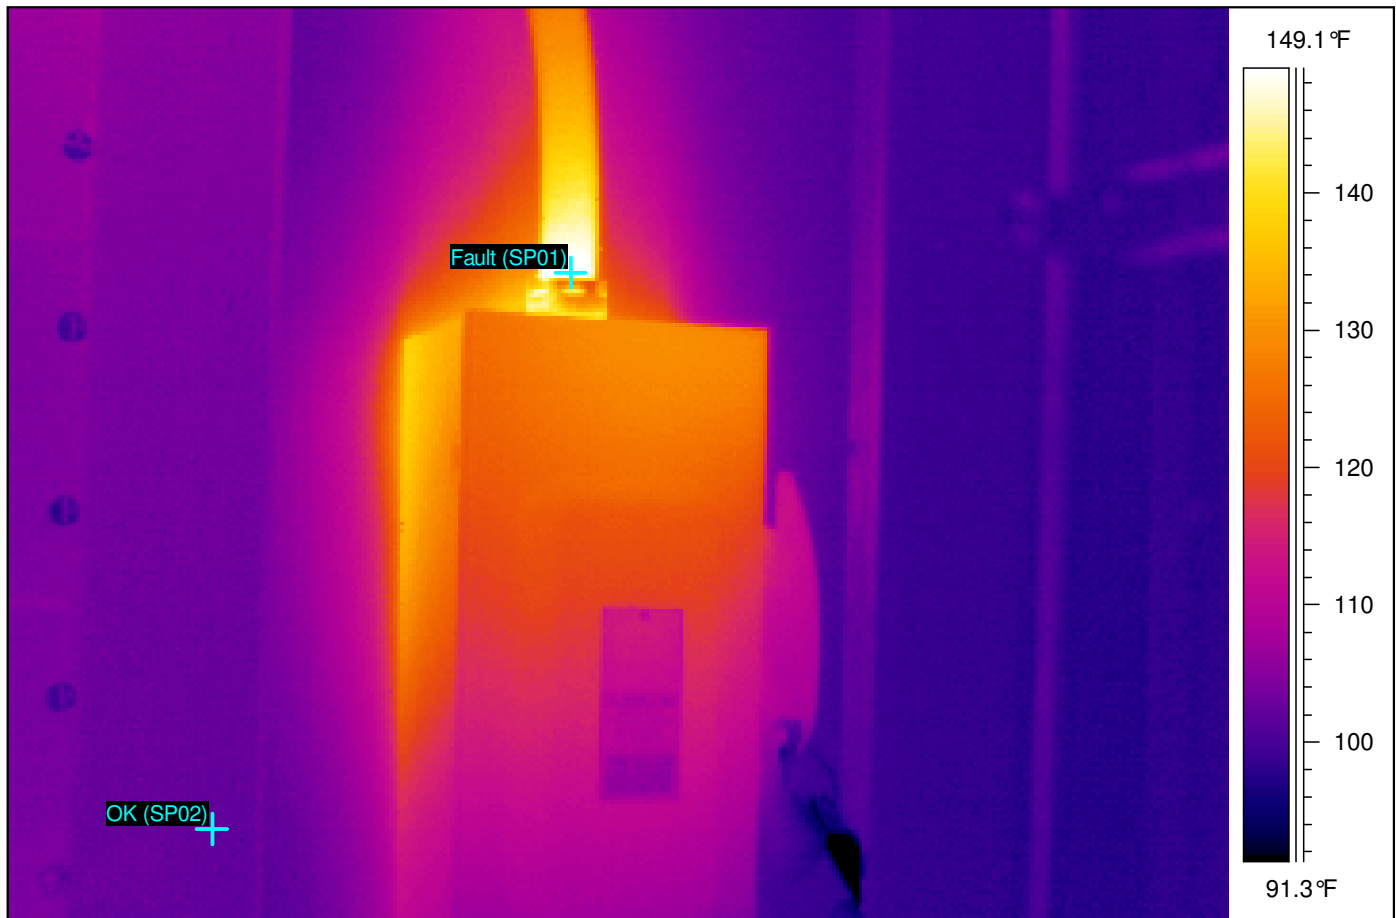
(SP01)

FAULT	150.5°F	OK	102.8°F	RISE	47.7 °F
-------	---------	----	---------	------	---------

This disconnect was de-energized on Friday afternoon. This image was taken on the following Monday morning. The disconnect shows signs of the presents of electrical energy in spite of the switch handle being in the open position. The power to the MCC feeding this disconnect should be de-energized prior to further examination. This is an example of why we use a standard procedure to test for the presence of voltage before working on electrical equipment. 'Test Before Touch'

Yes, the ambient temperature is accurate. The MCC is located in a hot enviroment.
